## Failure mechanisms of bridge infrastructure in an extreme flood event

Lebbe, Mohamed Farook Kalendher and Lokuge, Weena and Setunge, Sujeeva and Zhang, Kevin (2014) *Failure mechanisms of bridge infrastructure in an extreme flood event*. In: Proceedings of the First International Conference on Infrastructure Failures and Consequences, 16-20 July 2014, Melbourne, pp124-132. ISBN: 978-0-9925570-1-0

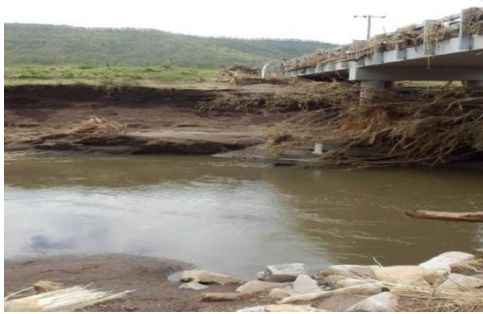
Bridge No. 2 abutment headstock damaged

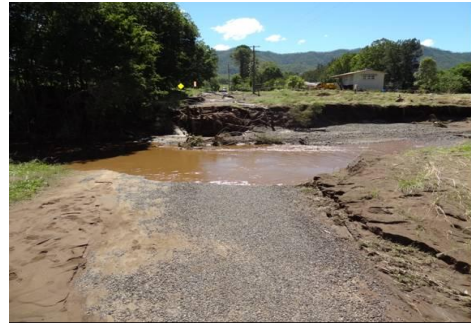
Bridge No. 16 completely washed away

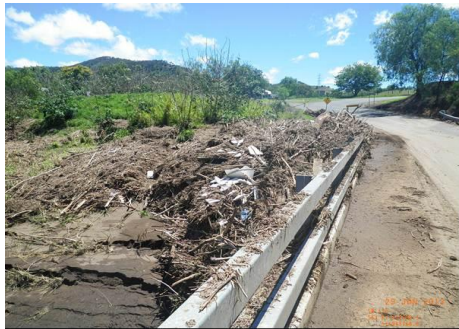
Damaged due to debris

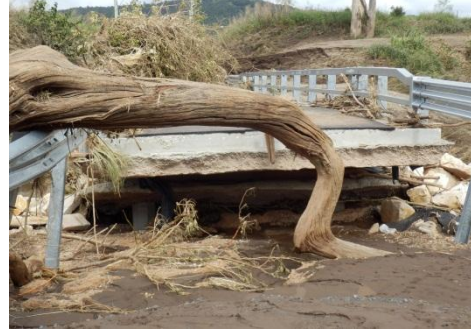
Damaged relieving slab
